OPERATIONAL CHALLENGES OF 85MHz DEPLOYMENT

Changing an HFC network from a 42 MHz split to an 85 MHz split, or an even higher frequency split such as 200 MHz, presents significant operational challenges in the home and local access networks. These challenges result from the dramatic change in level experienced in the home and local access network as the frequencies shift from downstream usage to upstream usage as well as long-held assumptions about the frequencies used for downstream transmission.

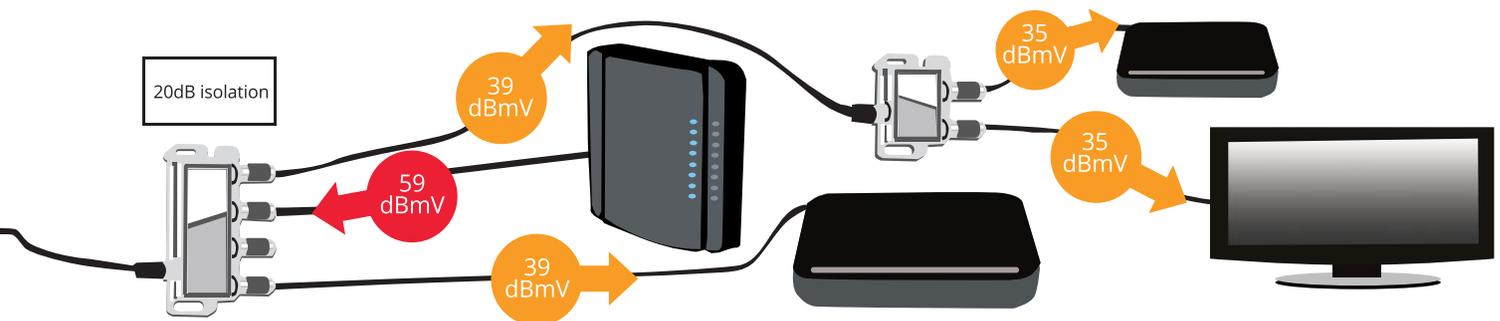
Figure 1

The upstream transmit signal from an 85 MHz cable modem is potentially quite powerful. As an example, in DOCSIS 3.1, the transmit level of a minimally sized 24 MHz signal can be up to 56dBmV relative to 6 MHz. As is shown in Figure 1, the transmitted signal will leak to other ports within each splitter that the signal crosses.

The isolation of the ports in the splitter sets the amount of leakage that will be seen on the other ports. Common inexpensive splitters may have isolation as low as 20dB from port to port. Better quality splitters may have more loss, or less leaked energy, but at the DOCSIS3.0 or 3.1 power levels, some energy will leak through. That energy, as is shown in the diagram, travels back through the rest of the home network.

When the leaked signal reaches a device, the AGC may react. For example, if the leaked signal has a loss of 30dB, it could reach a directly connected set-top box at 26dBmV, a much higher level than the typical 0dBmV downstream video signal within the home. When the AGC detects the higher power level, it will attenuate the entire downstream signal. If the attenuation is too high, the desired downstream video signal will be degraded or lost. The amount of additional attenuation present between the leakage signal and the affected device will vary depending upon the splitter arrangement within the home.

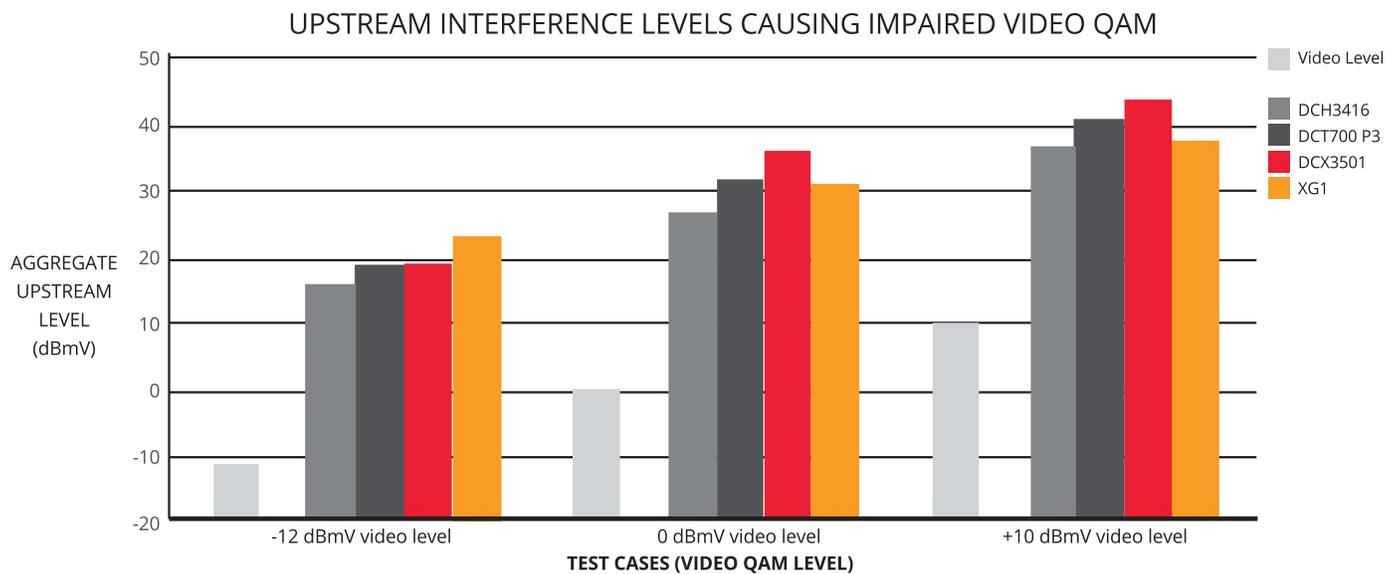
Figure 2

ARRIS tested a collection of set-top boxes to determine what level of signal leakage tended to cause problems. Results of the testing are shown in Figure 2.

The devices under test were tuned to a 256 QAM video channel at 111 MHz, with a full video channel load present up to 945 MHz. A block of upstream signals was added between 54.3 MHz and 74.5 MHz. The block was varied in level to discover at what level video degradation occurred. As would be expected, the level of the video signal as well as the level of the upstream signal both influenced the problem. One way to describe the result is that the difference between downstream video level and the 85 MHz upstream level must be less than 25dB to avoid problems in the majority of set-top boxes.

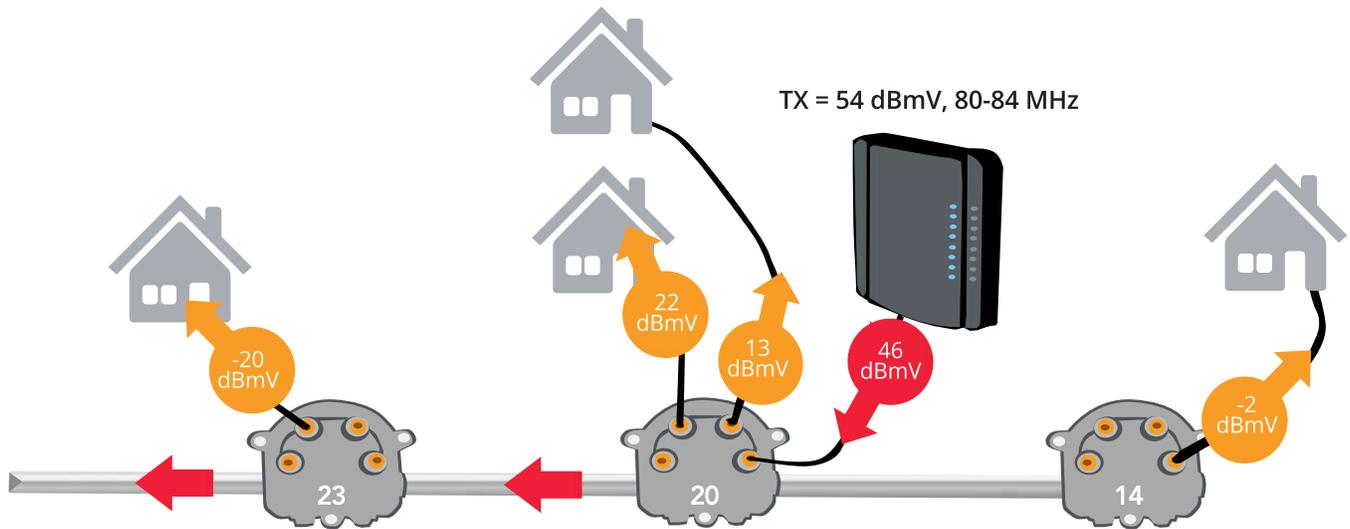
Figure 3

The problem of unexpected reflected energy in the downstream tuner's receive band is not limited to the home where a new 85 MHz cable modem is deployed. ARRIS also tested the performance of some taps. The test setup annotated with sample test results is shown in Figure 3.

The internal circuitry of a tap is equivalent to a directional coupler tapping the trunk line with a splitter dividing that tapped energy to the tap's F-connector ports. When a signal is sent from one home into a port on a tap, reflections or leakage are generated in the splitter circuitry within the tap. Another home that shares a tap's internal splitter can receive the leaked signal at a relatively high level. In testing, as little as 24dB of loss was seen from port to port of a standard tap. Since a set-top box in another home will still have drop cable loss as well as in-home splitter loss to reduce the reflected signal's power, the possibility of degraded performance is not as high as it is in the original home, but if the incoming video level is low, the stray signal could still cause problems. Many tap specs have higher isolation levels, but it is advisable to actually test representative examples of equipment found in the plant to see how the equipment performs.

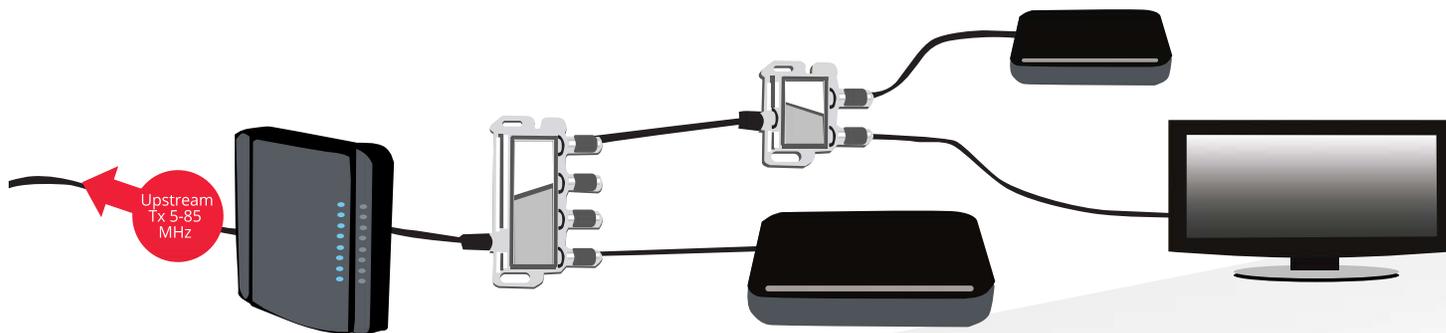
Figure 4

One approach to preventing in-home issues is to use a two-port cable modem for 85 MHz deployments as shown in Figure 4.

One port addresses the hybrid fiber coax (HFC) network and the other port addresses the home network. Using this device eliminates the possibility of interference in the home by directing all upstream transmissions directly onto the HFC network.

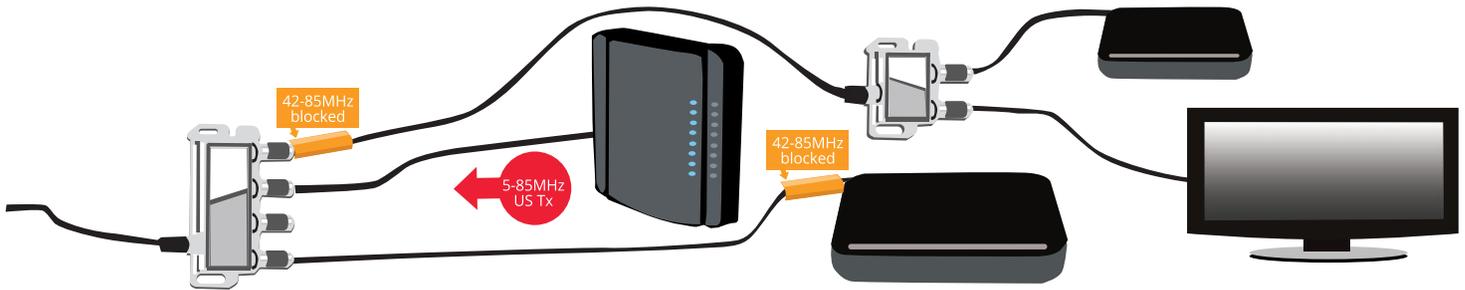
Figure 5

Alternatively, if a traditional cable modem configuration with a single port is used, filters that block signals between 42 MHz and 85 MHz can be added to each set-top box or other cable receiving device or alternatively to a leg to protect multiple device.

Note that a simple high pass filter is probably not sufficient, since most set-top boxes have internal DOCSIS modems or other OOB means to transmit upstream. A simple high pass filter can change those two-way devices into one-way devices. A bandpass filter can be used to just block the offending transmissions between 42 MHz and 85 MHz while still allowing upstream transmission in the original upstream band.

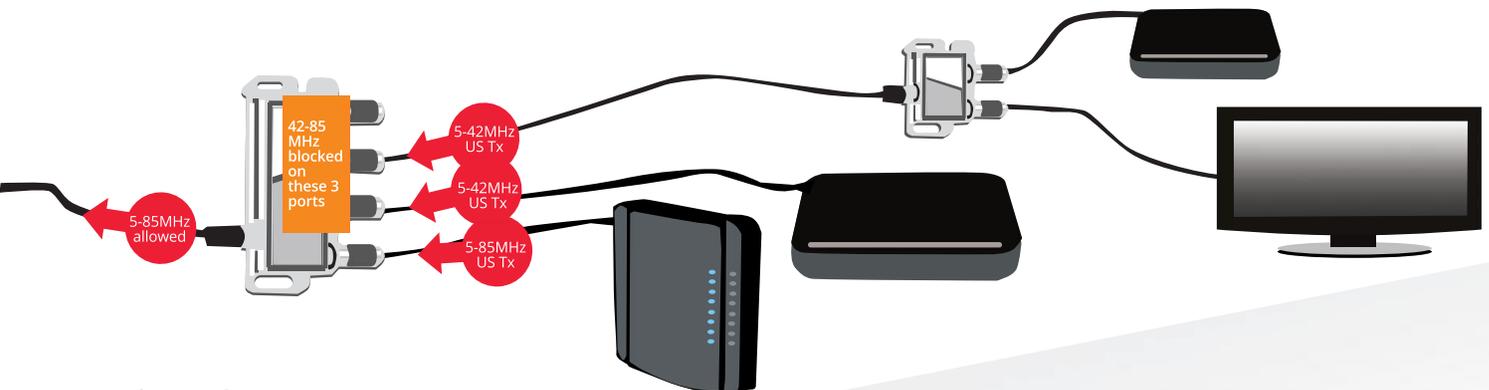
Figure 6

Alternatively, a new splitter with internal filtering could be placed at the top of the home network, similar to common practice with EMTAs today as shown in Figure 6.

The new splitter could have a port with additional filtering appropriate for an 85 MHz cable modem. The additional filtering can prevent reflections in the 42-85 MHz band from reaching the other ports used for the home.
